Manhole Inspection Summary

Manhole # S33C__004MH

Location Address: **rear 327 w mulberry st**

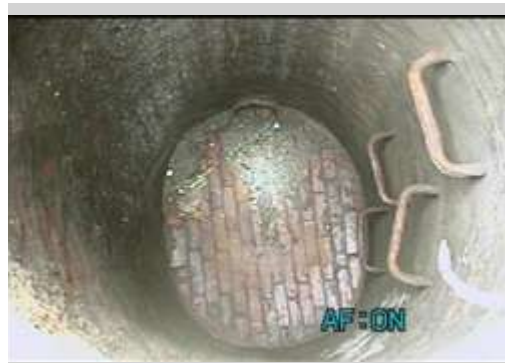
Top View

Count: **5** Missing: **1** ☒ **Corroded**

top view and steps

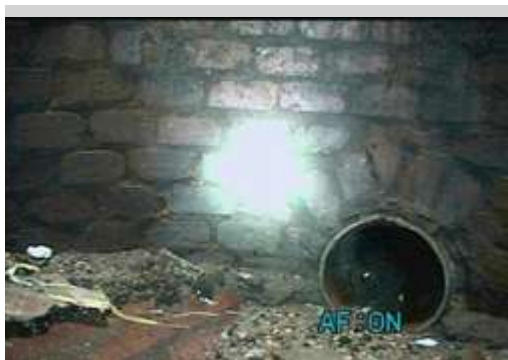
Defect 2

channel debris

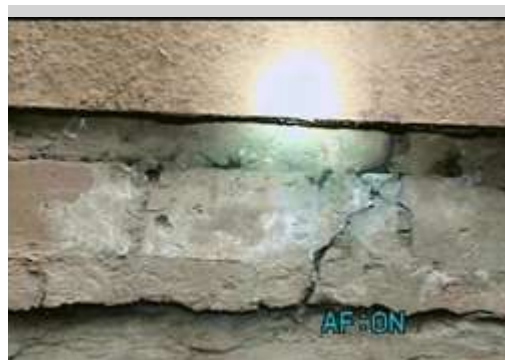
Defect 1

Condition: ☐ Sound ☒ **Cracked** ☐ Root Intrusion ☐ Loose Brick ☐ Deteriorated

chimney cond cracked

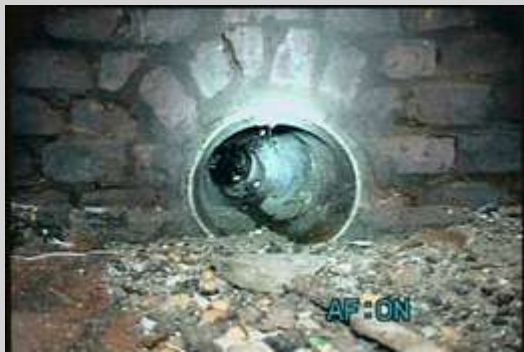
12 O'Clock Outflow

8 in. Circular Gravity Sewer
Pipe Out @ 12 O'Clock
